WHEELER STALLARD HOUSE  
EXTERIOR RENOVATION & REPAIRS

CHARLES CUNIFFE & ASSOCIATES/ARCHITECTS

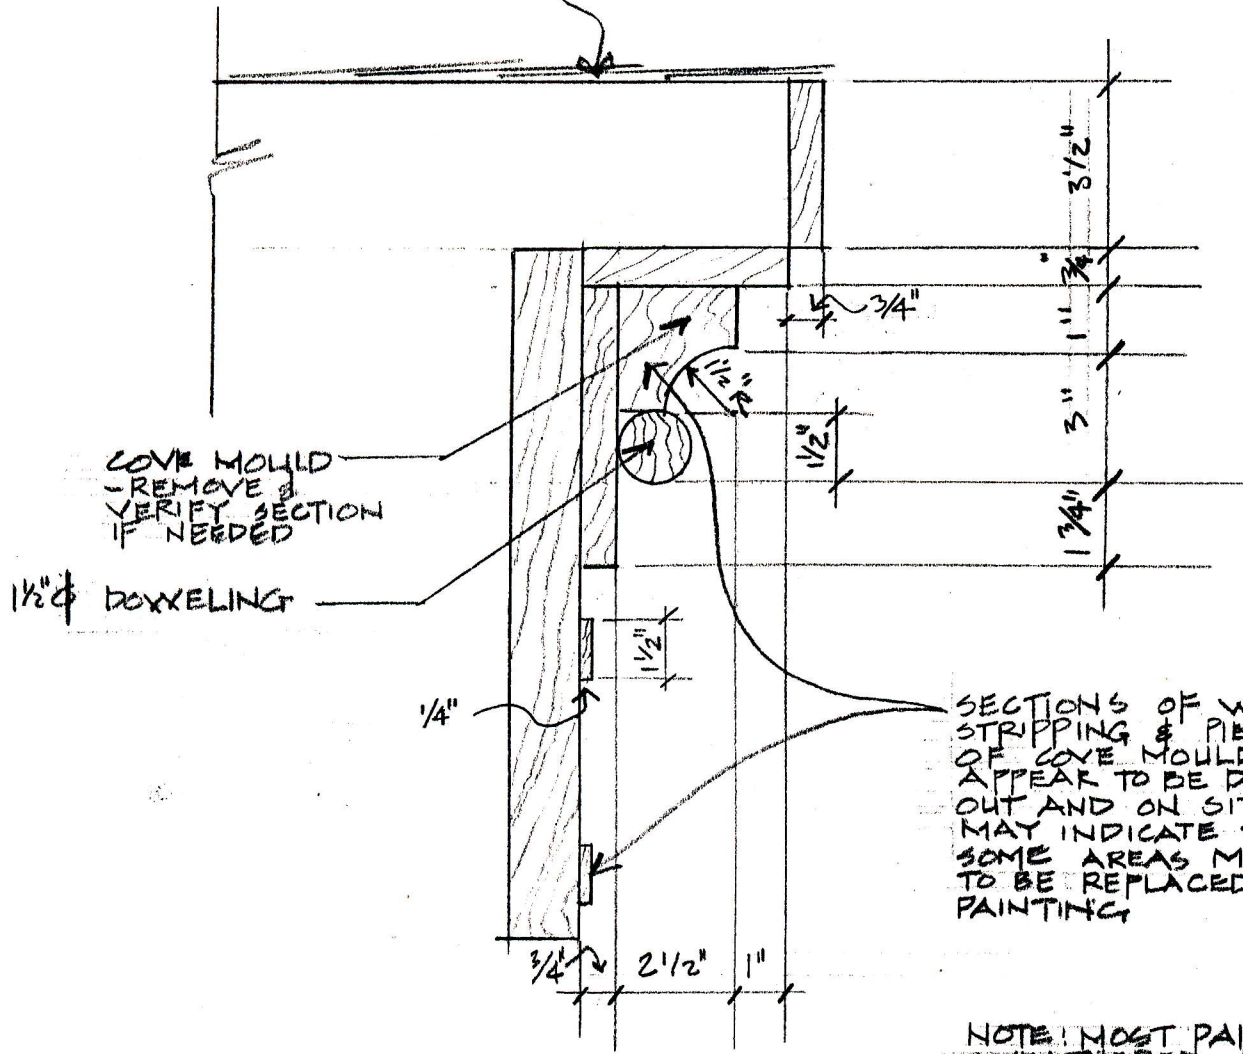
### FASCIA @ EAVE

SECTIONS OF WOOD  
STRIPPING & PIECES  
OF COVE MOULDING  
APPEAR TO BE DRY ROTTED  
OUT AND ON SITE INSPECTION  
MAY INDICATE THAT  
SOME AREAS MAY NEED  
TO BE REPLACED DURING  
PAINTING

NOTE: MOST PAINT HAS  
WEATHERED AWAY OR  
REMAINS IN LARGE FLAKES

COVE MOLD  
- REMOVE &  
VERIFY SECTION  
IF NEEDED
